Stoke Newington Church Street / Clissold Road Improved access to Clissold Park - Proposed parallel zebra crossing

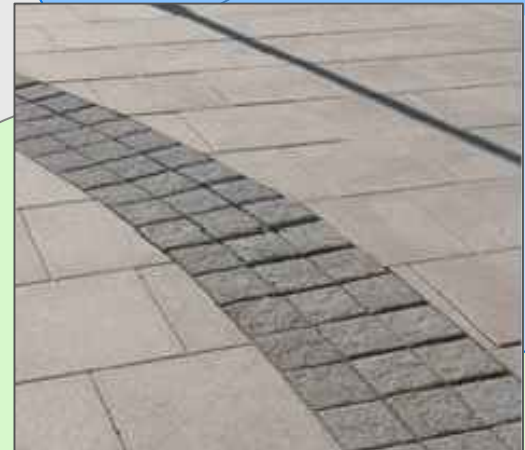
Example of shared surface edging

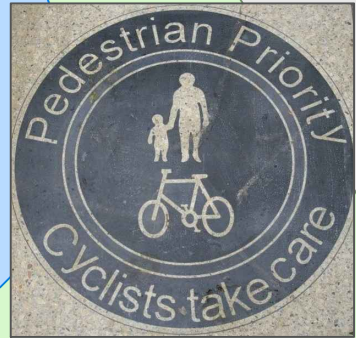
Example of shared surface paving slabs

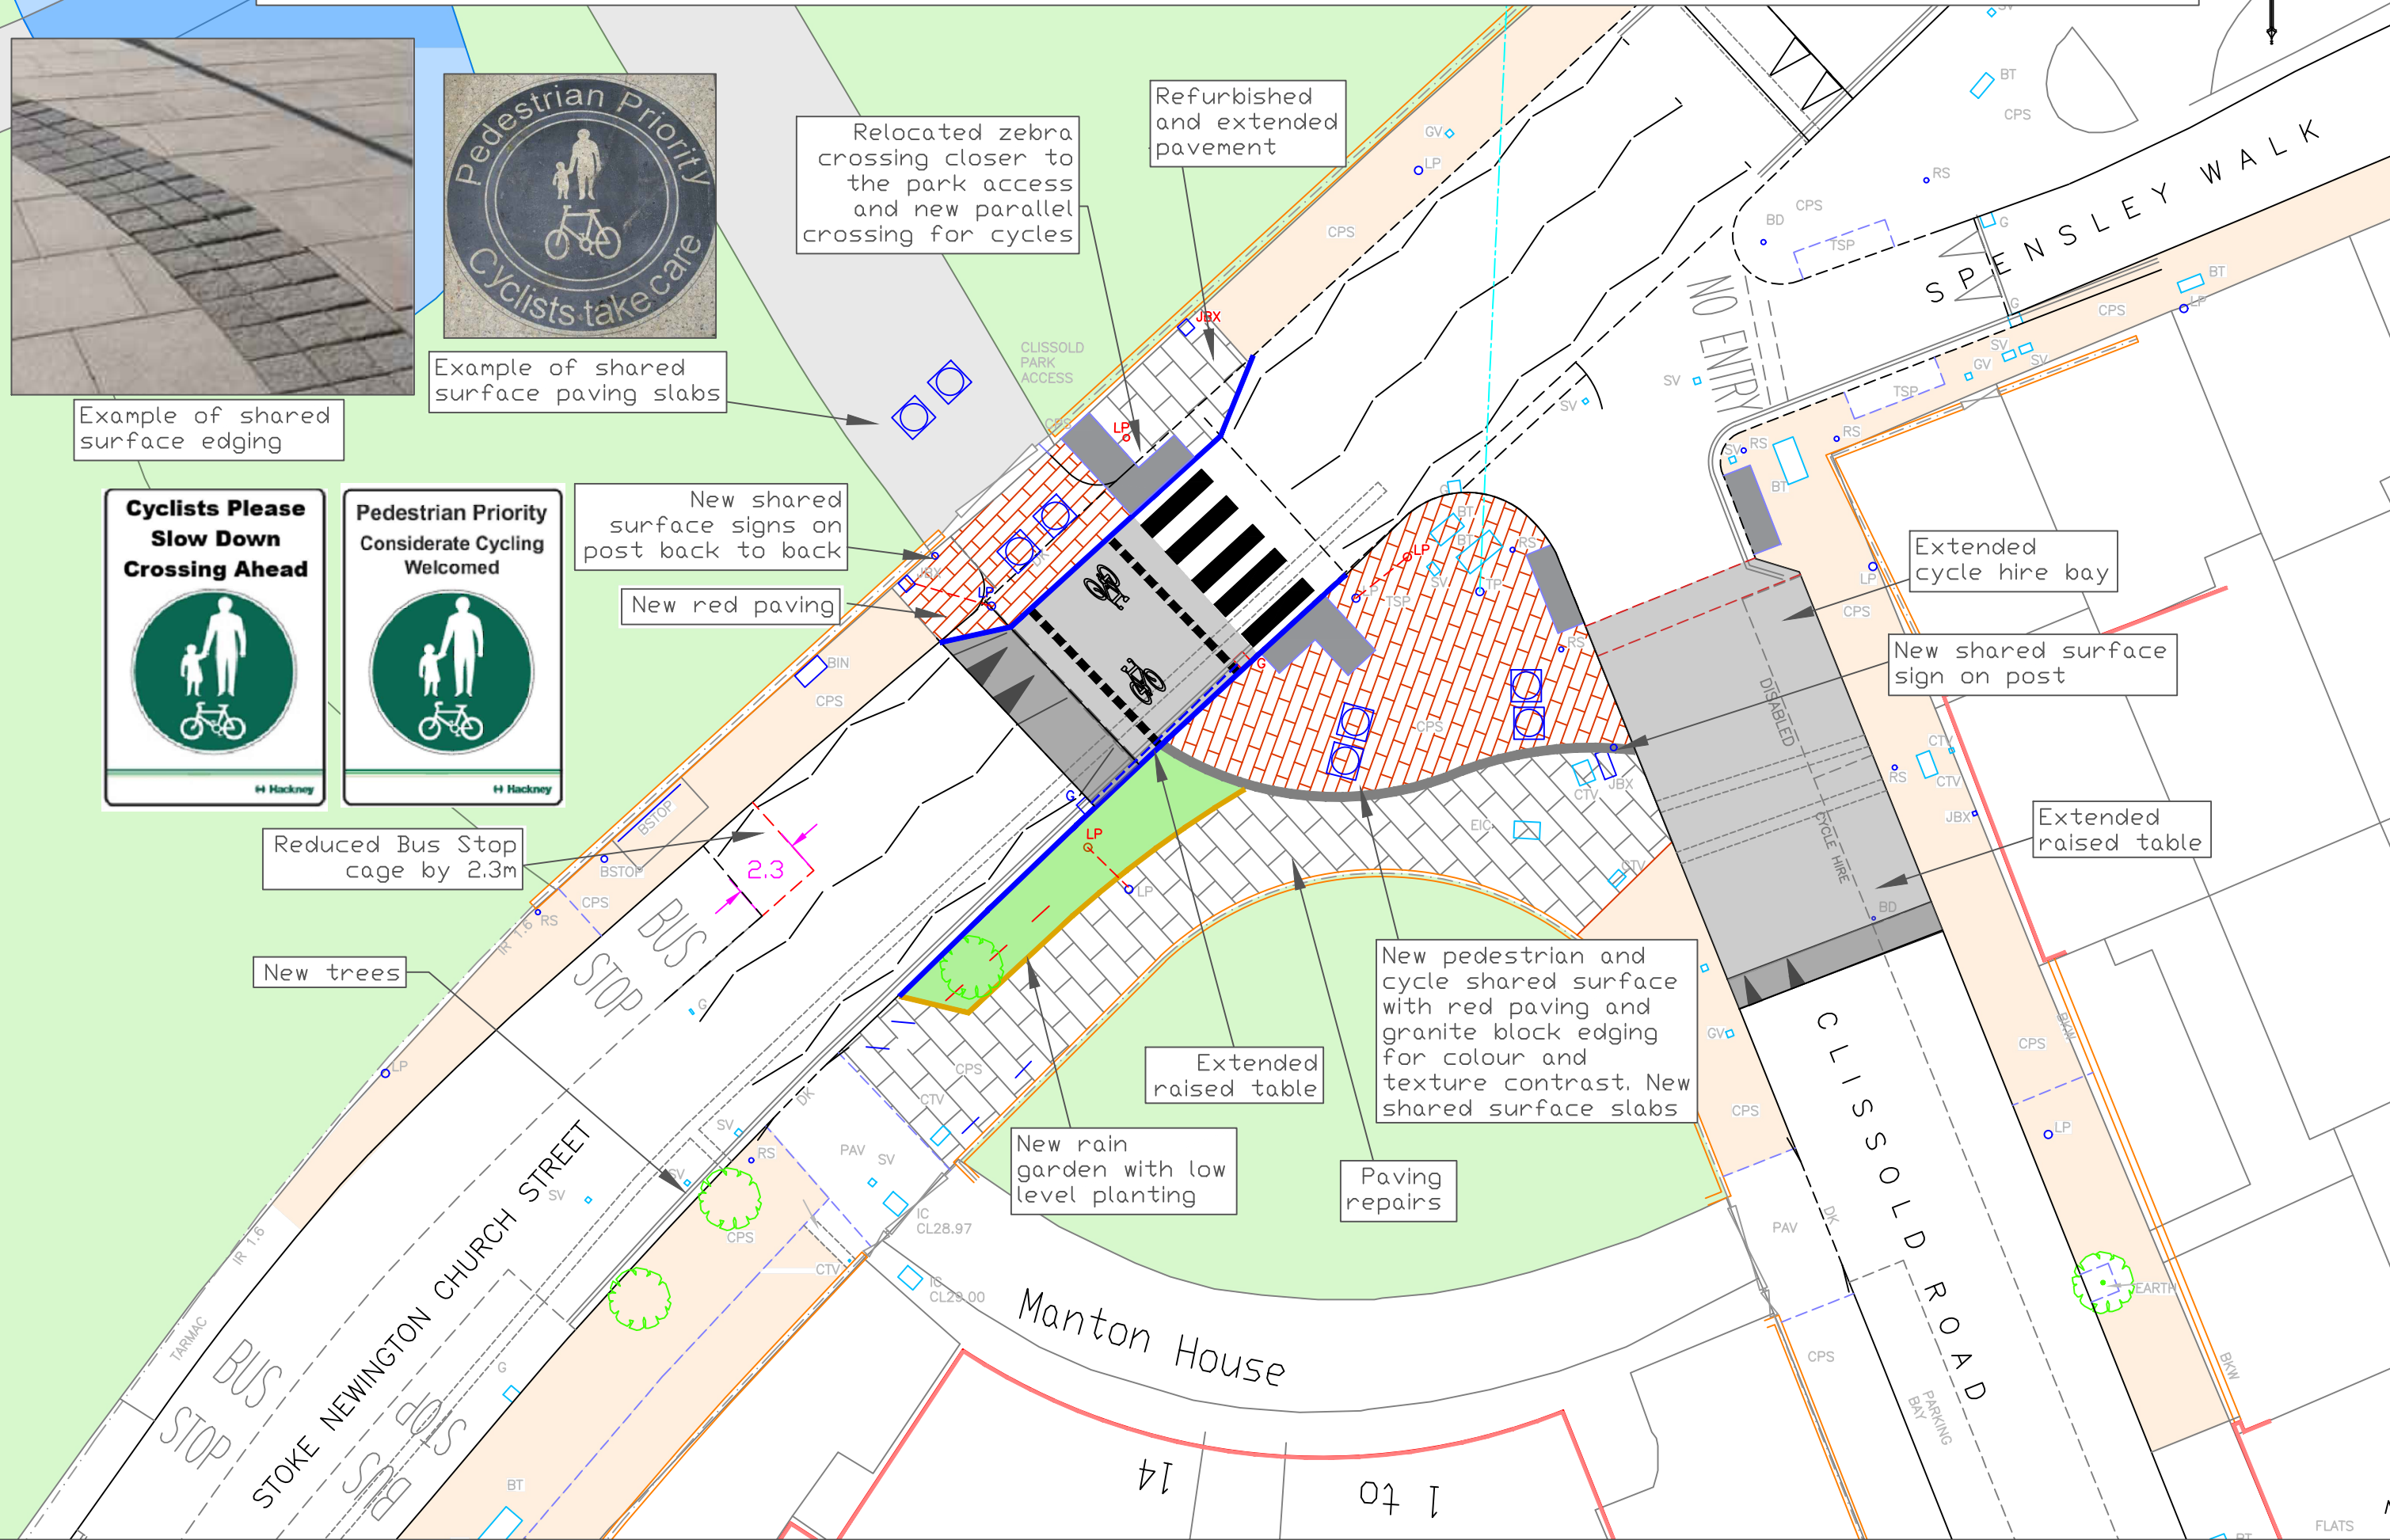
New shared surface signs on post back to back

Reduced Bus Stop cage by 2.3m

New trees

Relocated zebra crossing closer to the park access and new parallel crossing for cycles

Refurbished and extended pavement

New red paving

Extended cycle hire bay

New shared surface sign on post

Extended raised table

New pedestrian and cycle shared surface with red paving and granite block edging for colour and texture contrast. New shared surface slabs

New rain garden with low level planting

Paving repairs
